# Round 2 Remedial Action Reports

## Central Region Office Meter Station Facilities Washington Department of Ecology

**Northwest Pipeline GP/Williams Gas Pipeline  
P.O. Box 58900  
Salt Lake City, Utah 84158**

EPI Project Number: 47313.3

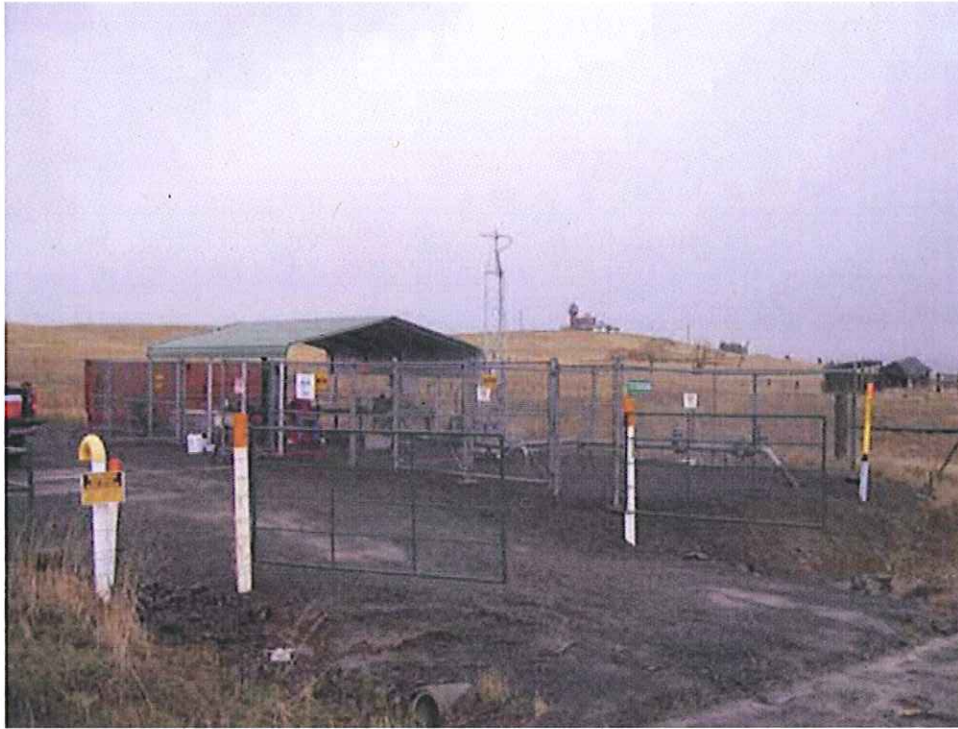
Photo KCMS-1  
Facility Overview

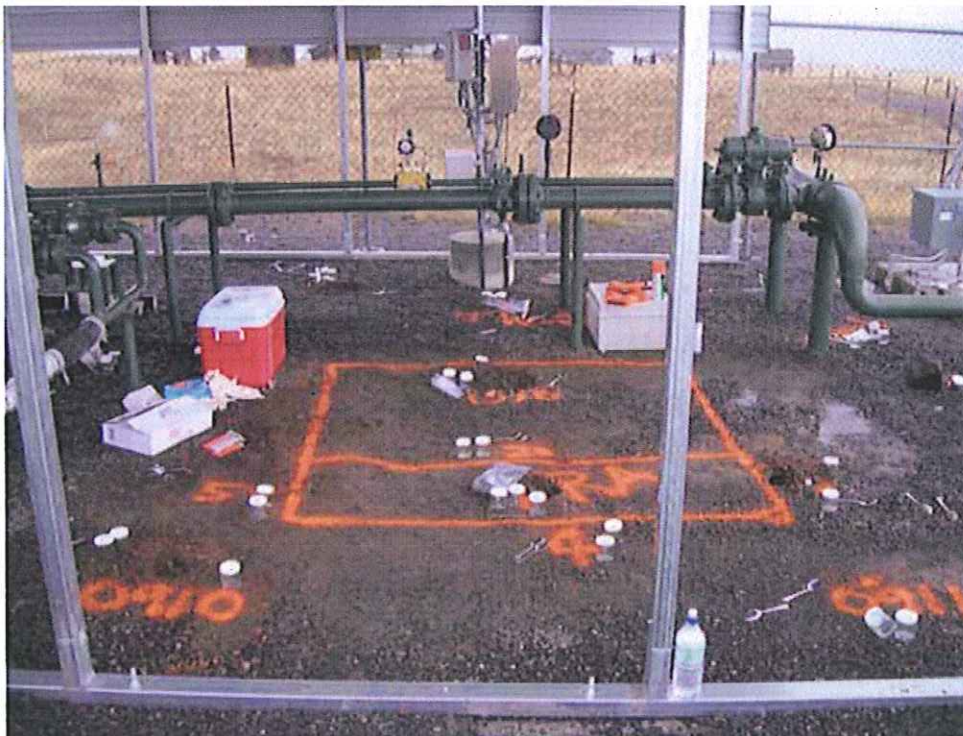
Photo KCMS-2  
Remediation in Progress

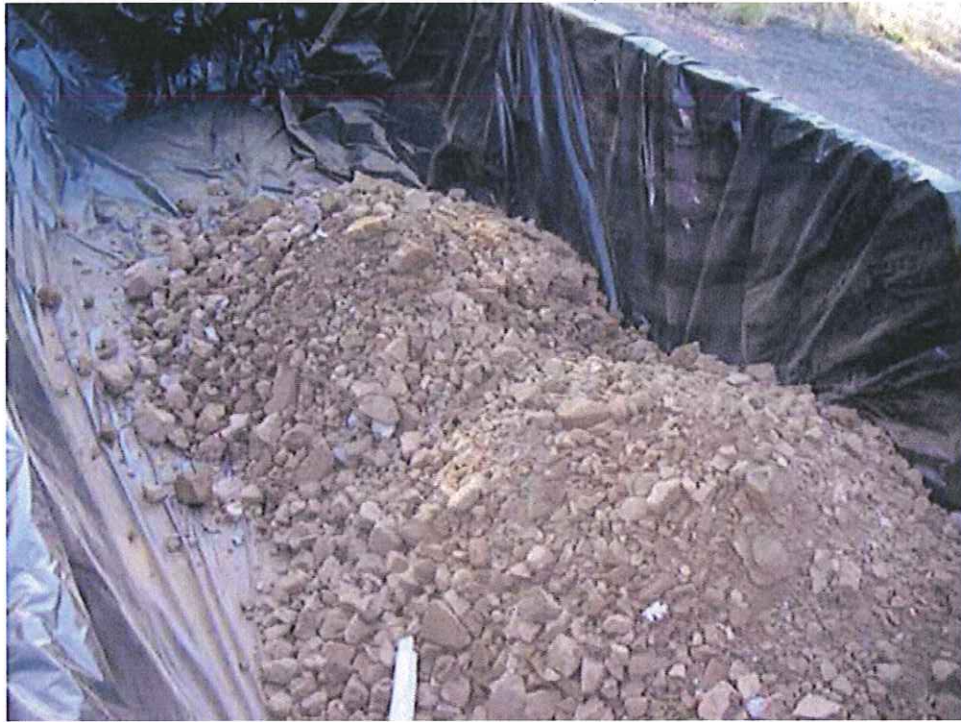
Photo HWMS-1  
Typical Subsurface Soils

Figure HWMS-6 illustrates the extent of the final remedial excavation and the locations and analytical results of the final performance samples. Photographs of the condition of the facility during remedial activities are presented as Photos HWMS-1 and HWMS-2 and are enclosed in Attachment HW-A.

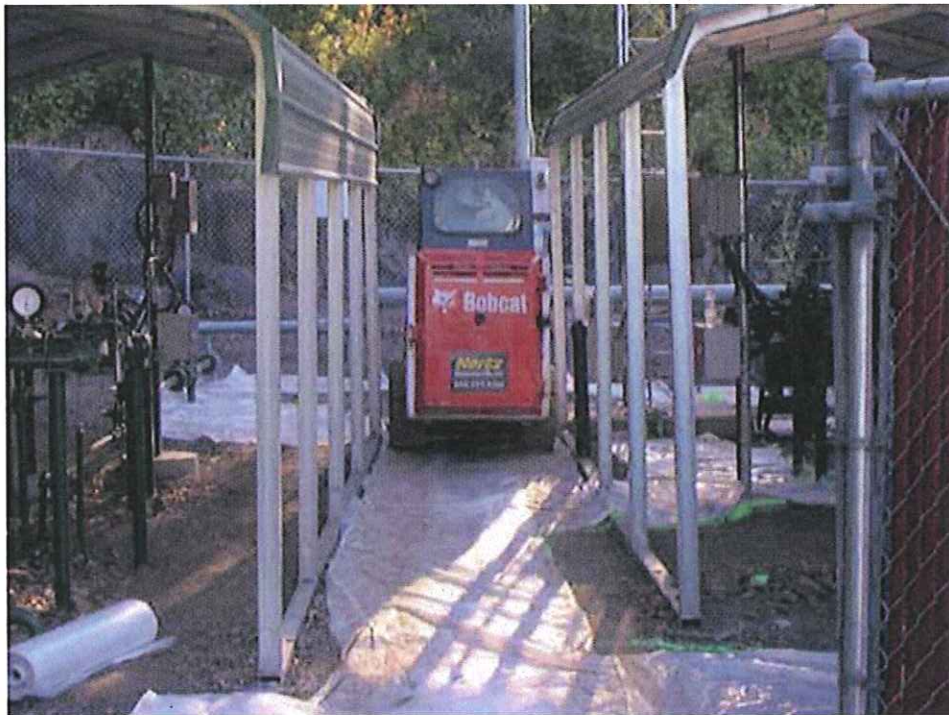
Photo HWMS-2  
Remediation in Progress
